ANNUAL REPORT FOR 2006

Roanoke Island Mitigation Site
Dare County
Project No. 8.1052501
TIP No. K-4003

Prepared By:
Natural Environment Unit & Roadside Environmental Unit
North Carolina Department of Transportation
February 2007

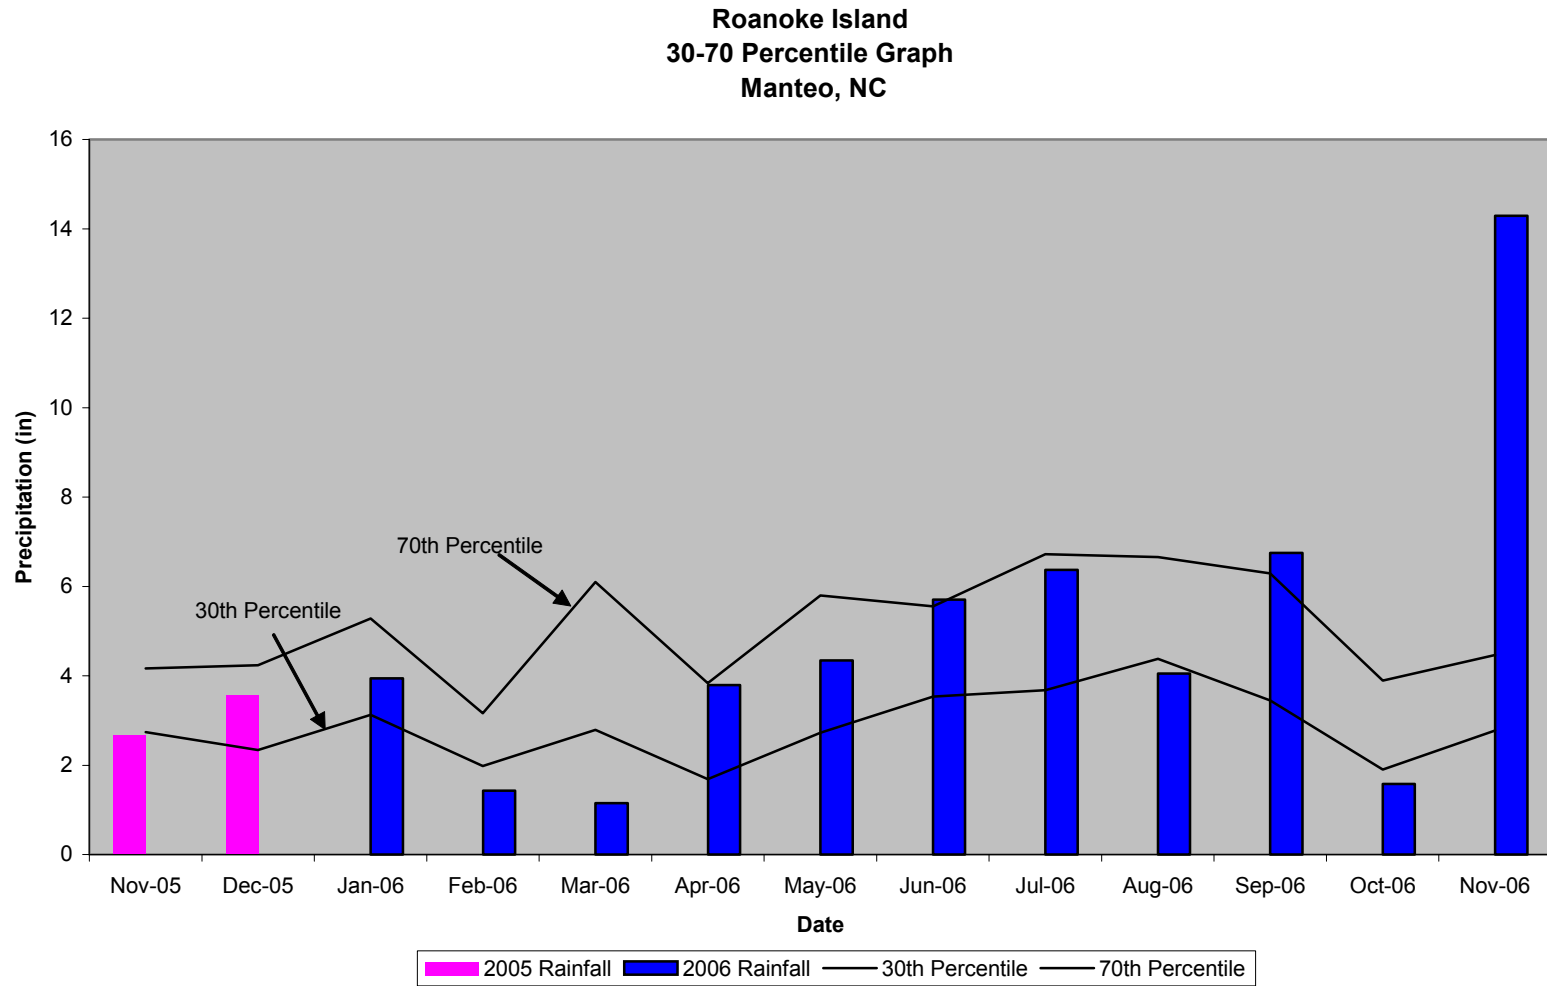
Figure 6. 30-70 Percentile Graph

Figure 6 provides an evaluation of the local climate in comparison with historical data in order to determine whether 2006 was “normal” in terms of climate conditions. The two lines represent the 30th and 70th percentiles of monthly precipitation for Manteo, NC. The bars are monthly rainfall totals for 2006. The historical data was collected from the State Climate Office of North Carolina.

For the 2006 year the below average rainfall includes; February, March, August, and October. January, April, May, June, and July experienced average rainfall. The months of September and November experienced above average rainfall for the year. Overall the site experienced average rainfall in 2006.
